CONTINUING ELIGIBILITY INSPECTION (CEI) REPORT

FOR FLOOD CONTROL WORKS
Honolulu Engineer District
CEPOH-EC-T

1. Project Name: Kuliouou Stream Flood Control Project
2. Date of Inspection: November 12, 2004
3. Inspection Personnel:

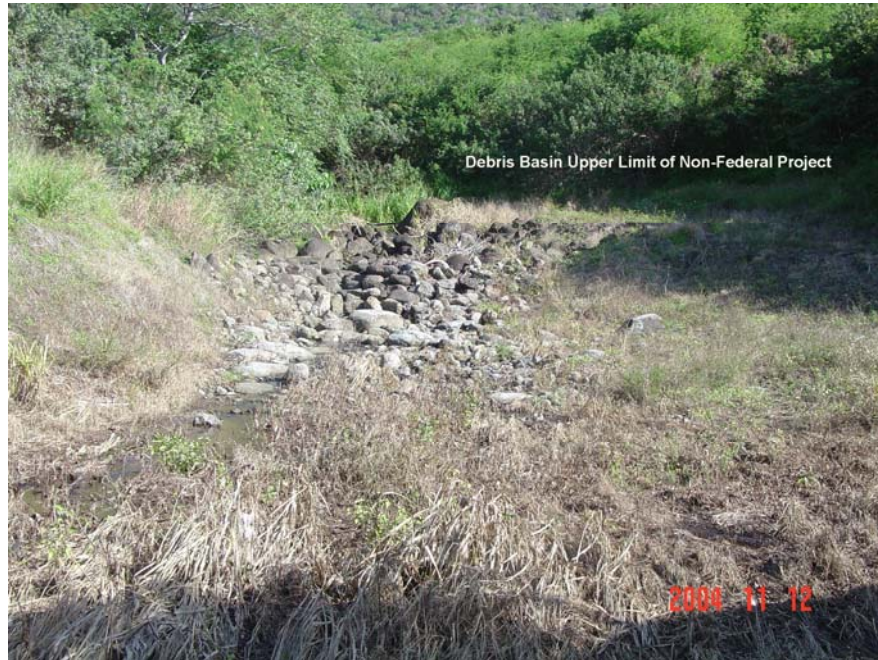
- a. Monitor Debris Basin for material build-up and remove as necessary. (Upper Limit of Non-Federal Project)

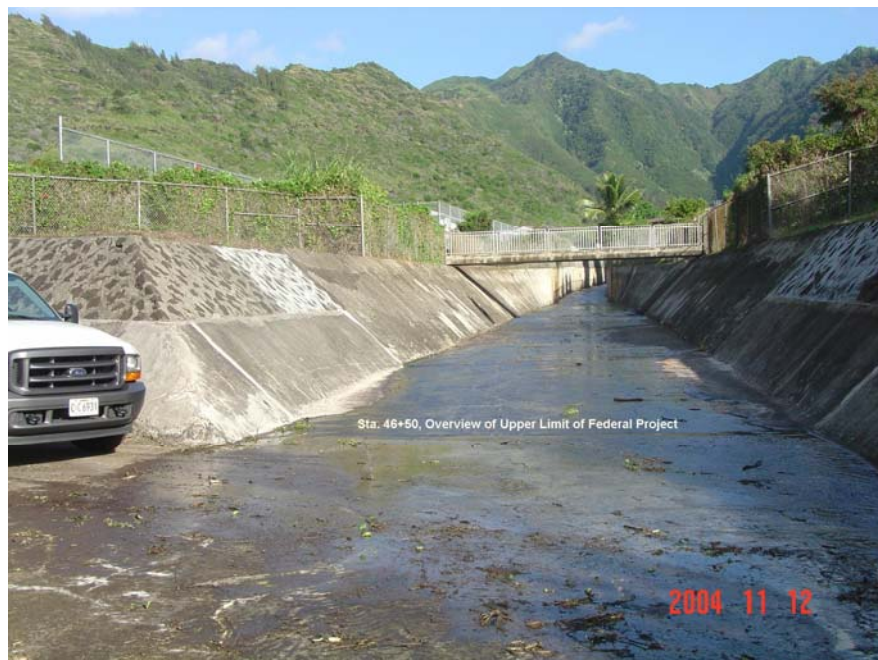
- b. Sta. 46+50, overview of the upper limit of the Federal project.

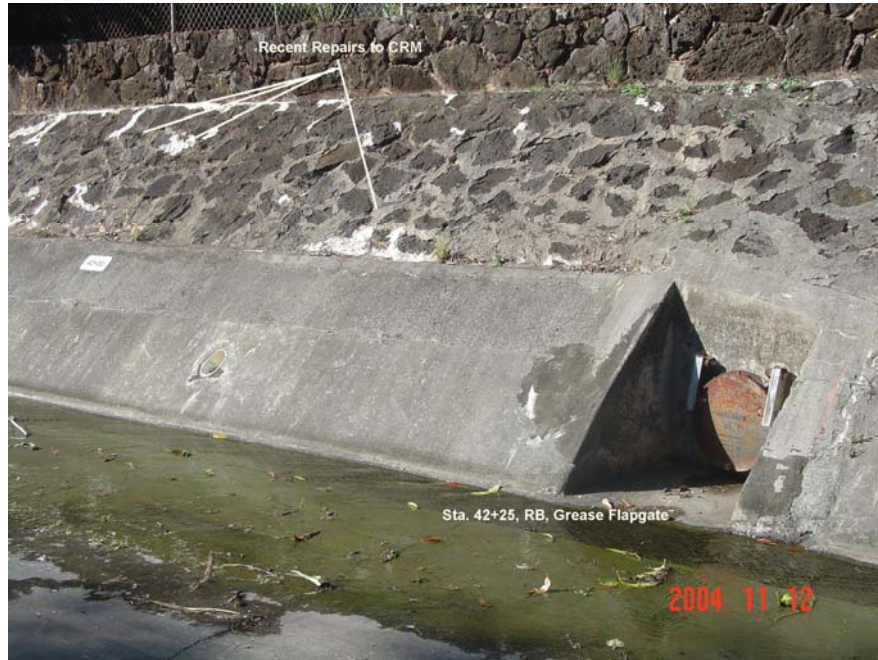
c. Sta. 42+25, Right Bank (RB), grease flapgate hinges, additional repairs were completed.

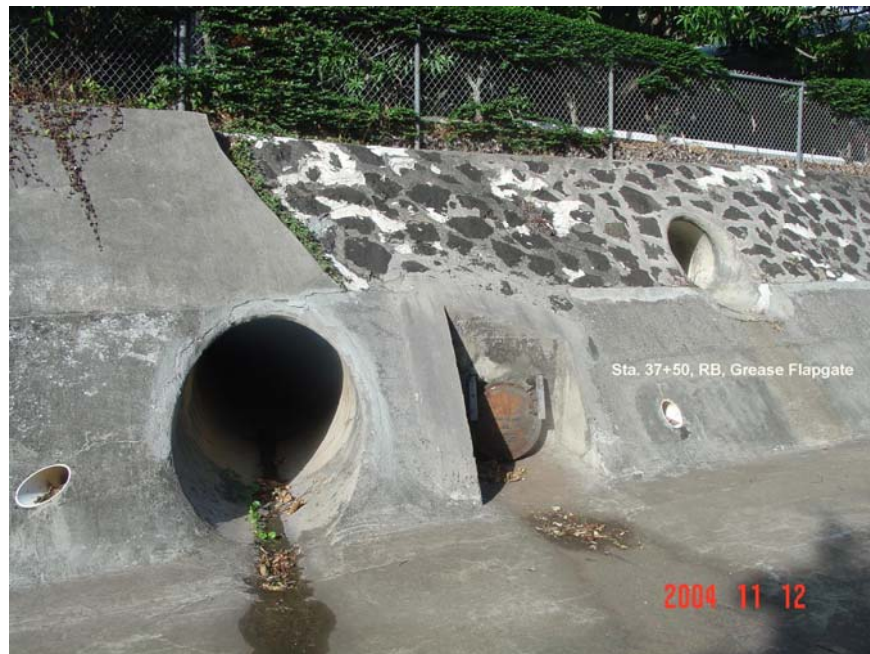
d. Sta. 37+50, RB, grease flapgate hinges.

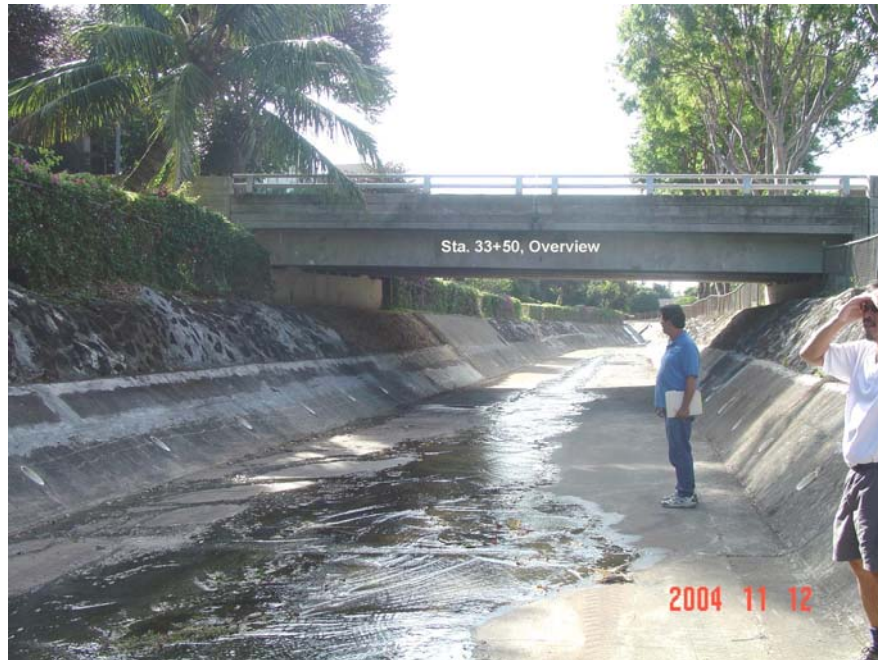
e. Sta. 33+50, overview of channel facing downstream.

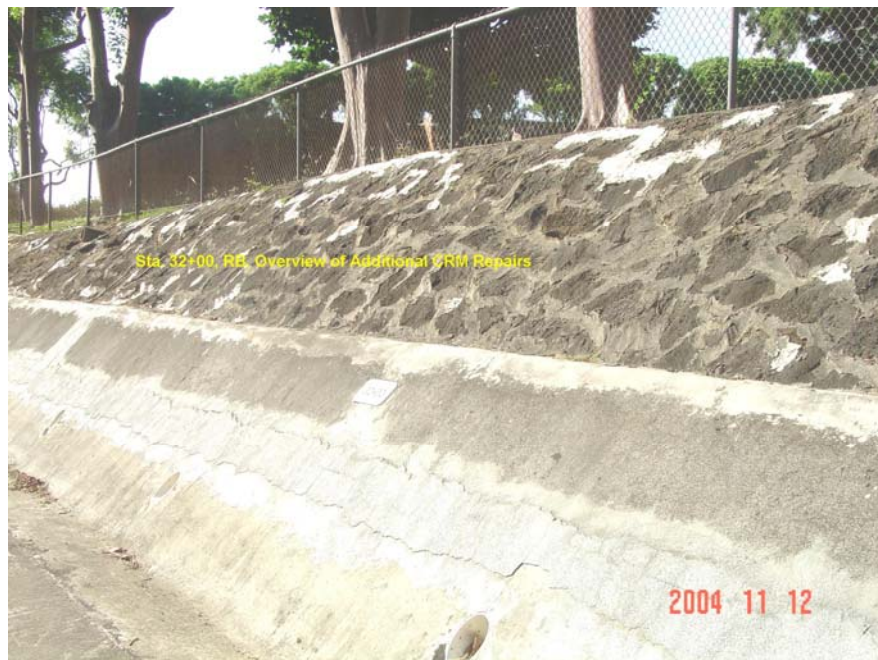
f. Sta. 32+00, RB, recent repairs are OK.

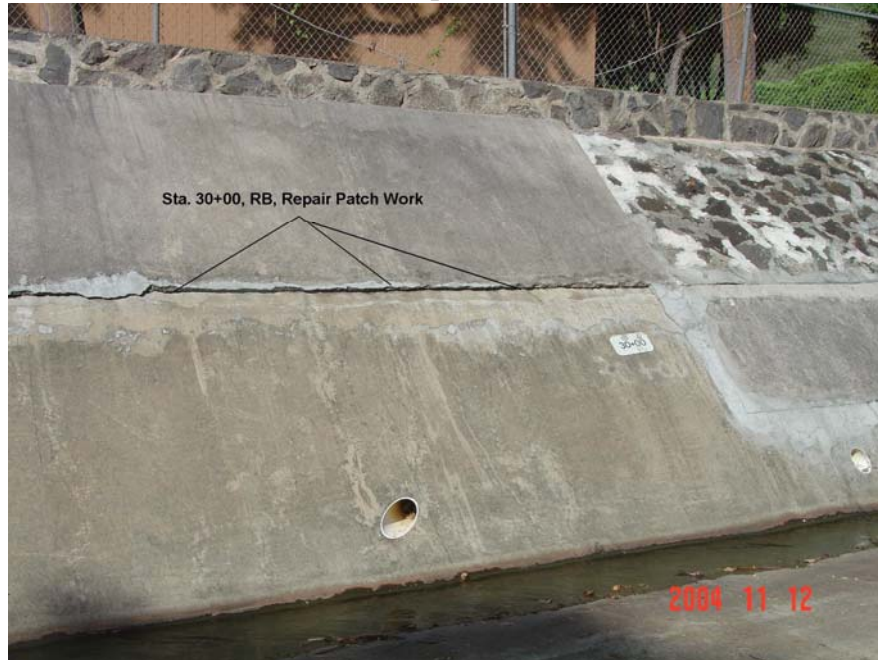
g. Sta. 30+00, RB, recent repairs, mortar patch scaling off, redo.

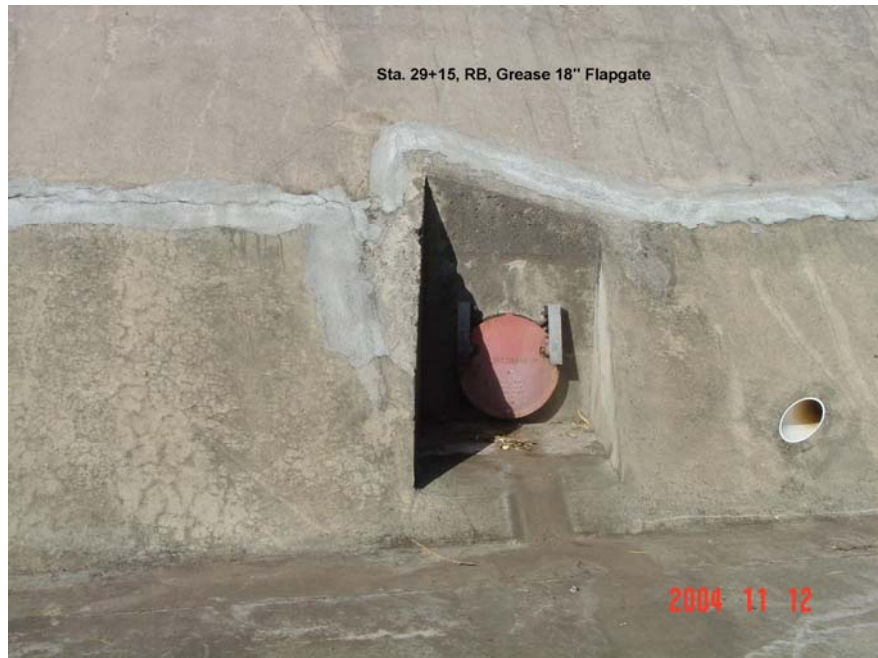
h. Sta. 29+15, RB, Grease flapgate.

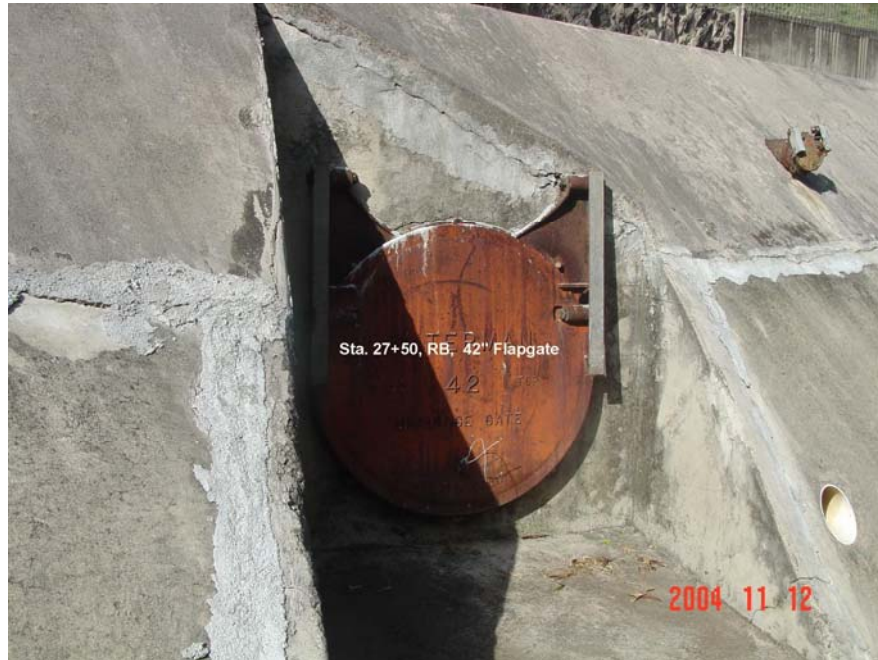
- i. Sta. 27+50, RB, grease flapgate.
- j. Sta. 26+00, RB, 6" replace missing flapgate.

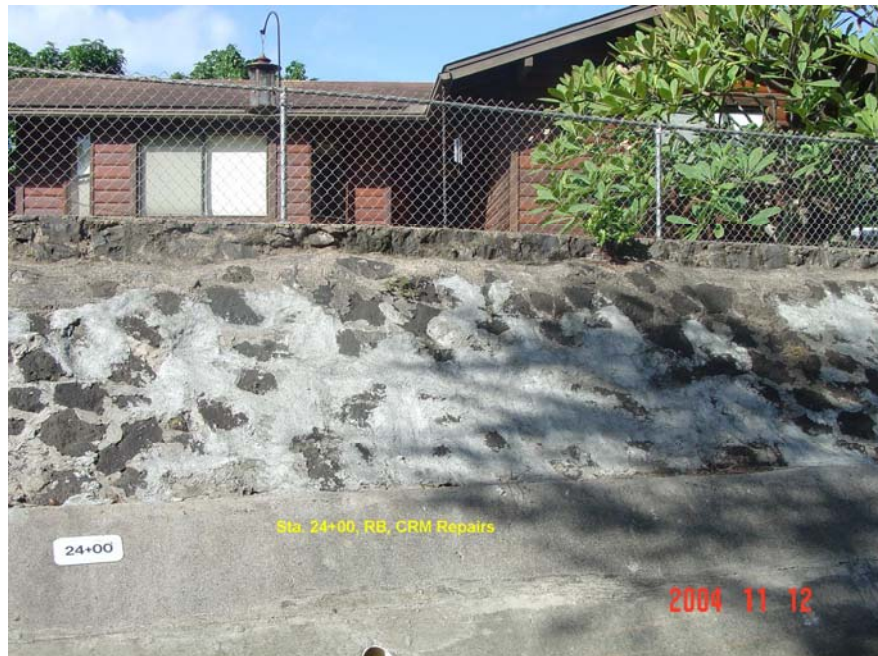
- k. Sta. 24+00, RB, vegetation removed from CRM wall.

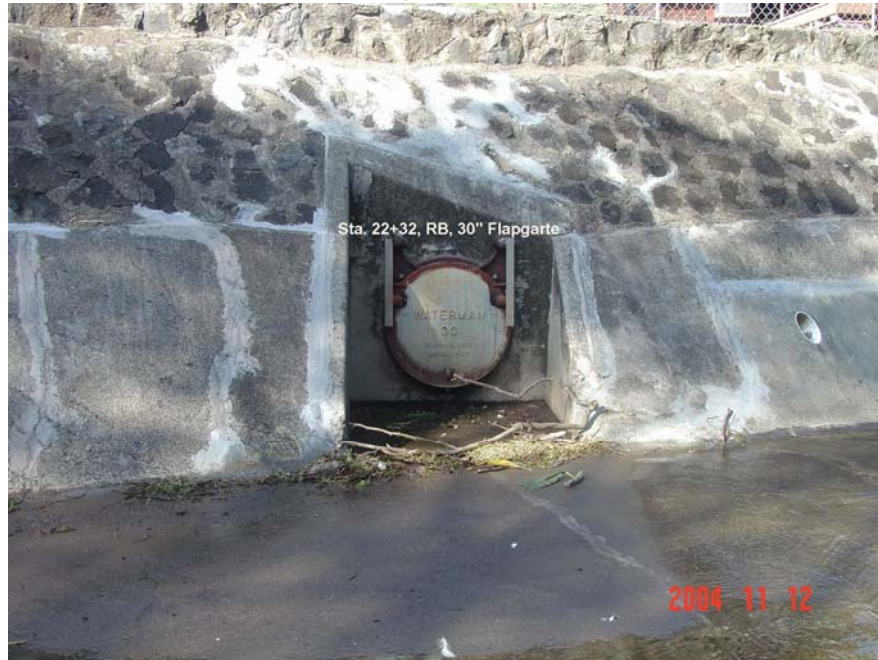
- m. Sta. 22+32, RB, water piping thru mortar patch, correct.

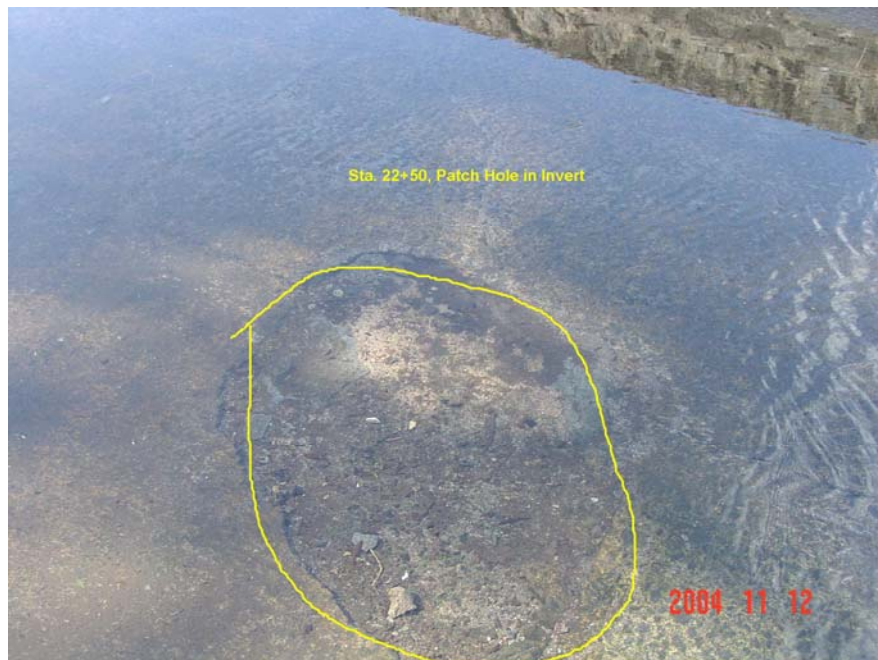
- n. Sta. 22+50, Invert, patch hole.

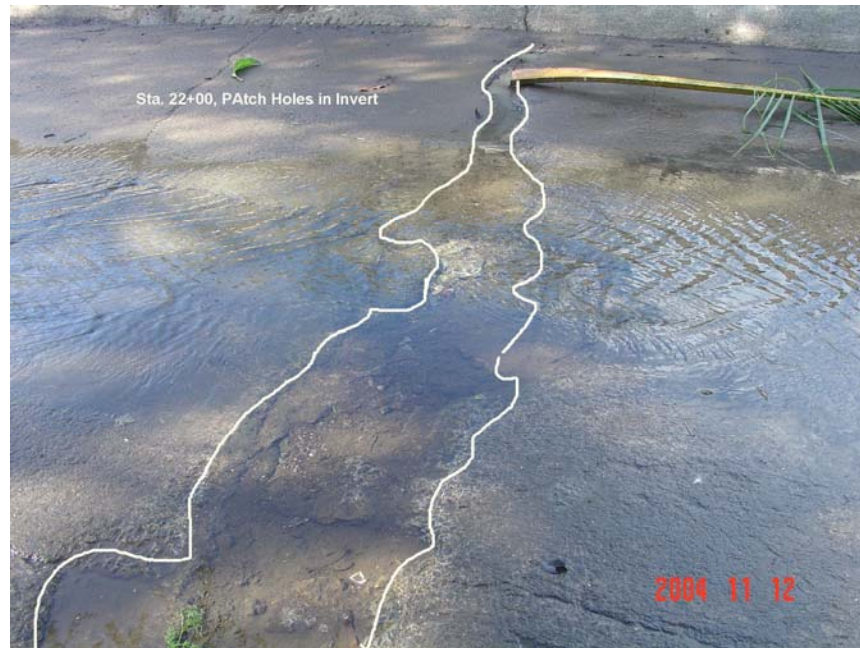
o. Sta. 22+00, Invert patch hole.

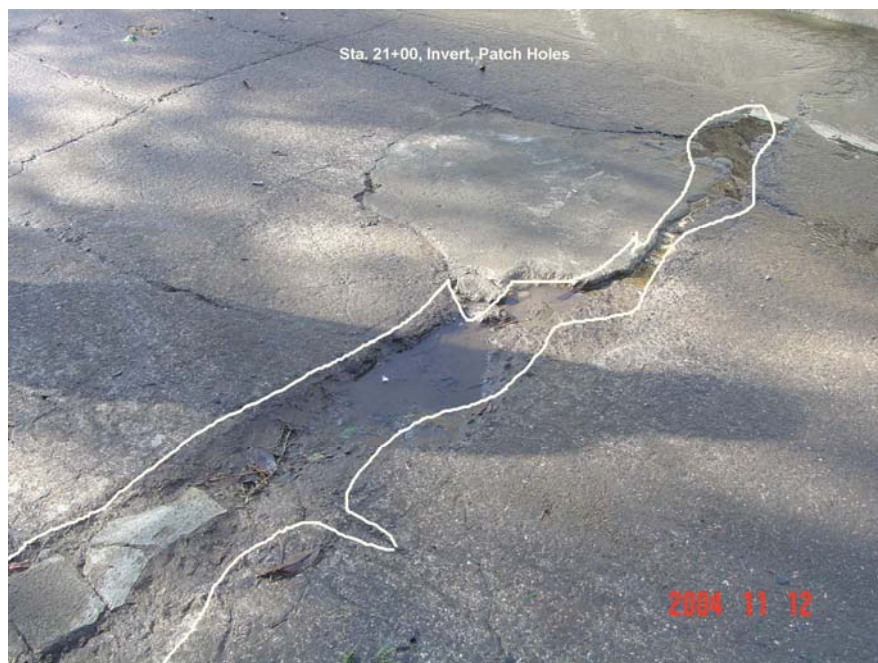
p. Sta/ 21+00, Invert, repair cracks and holes.

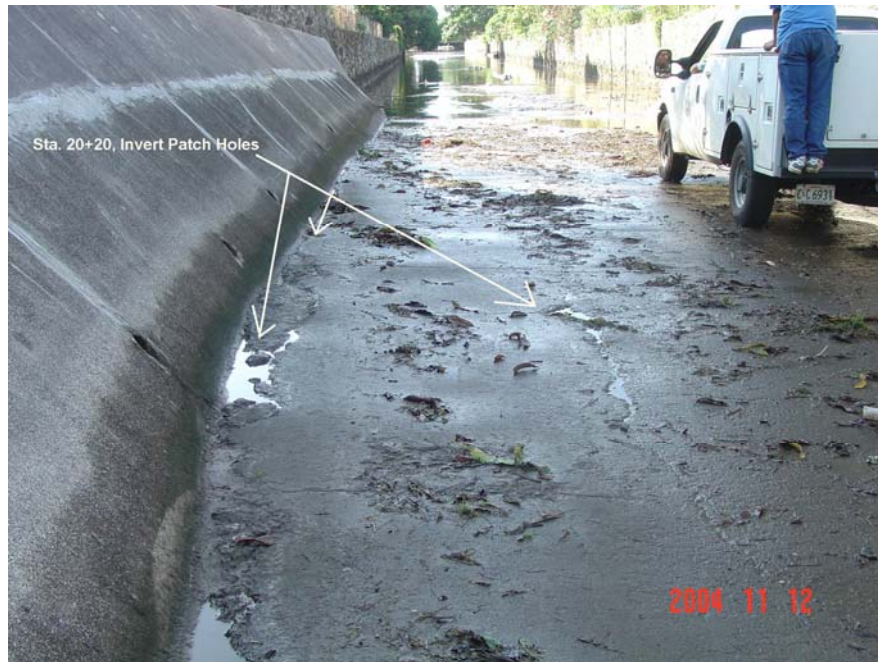
q. Sta. 20+20, Invert, patch hole.

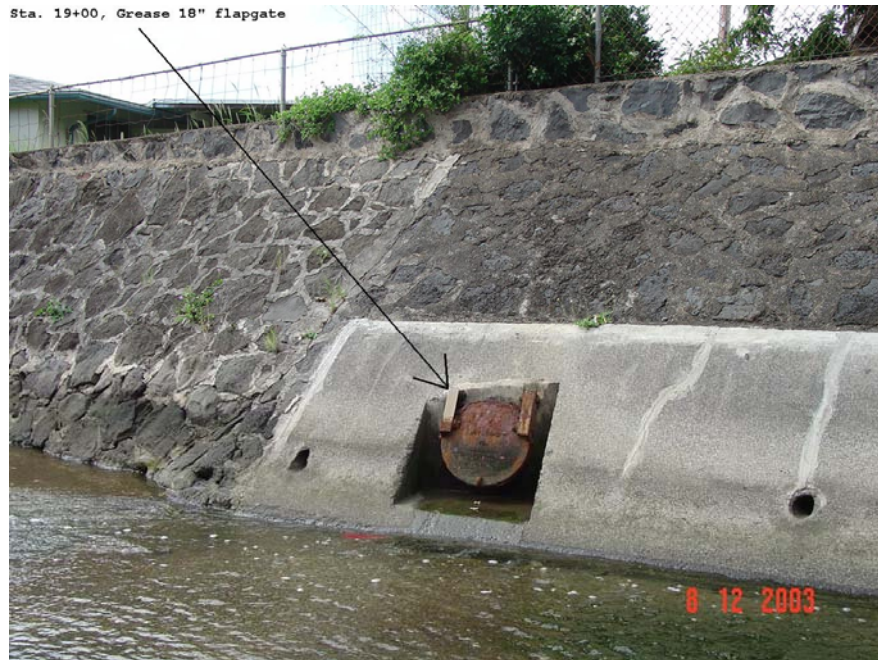
r. Sta. 19+00, RB, grease 18" flapgate.

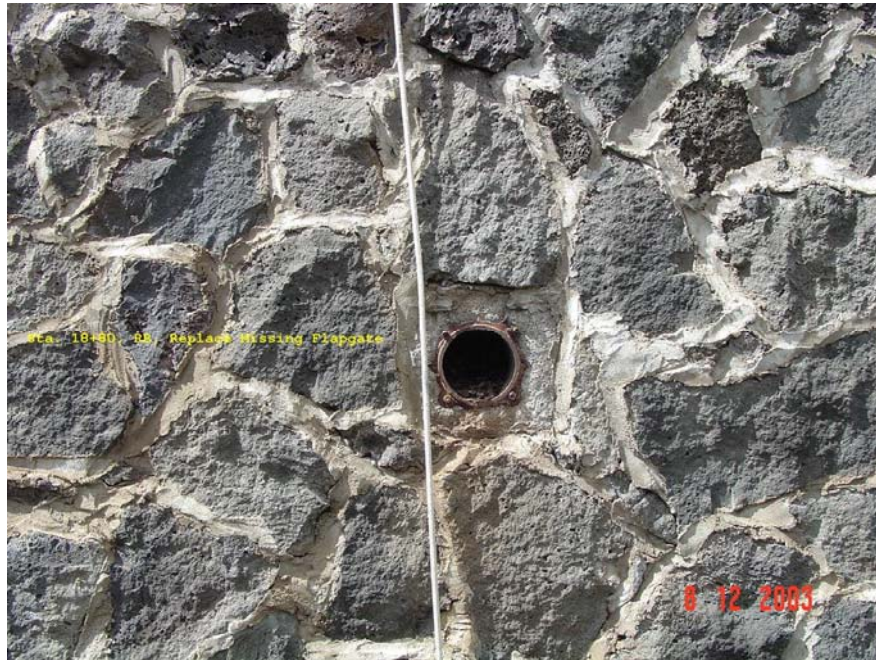
s. Sta. 18+40, RB, replace flapgate.

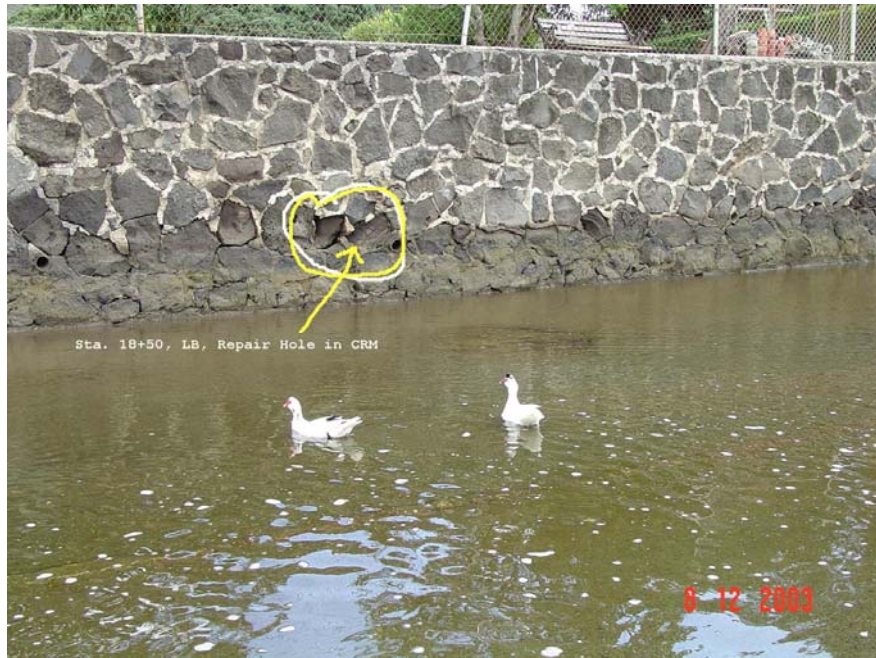
t. Sta. 18+50, LB, patch hole in CRM wall and patch invert.

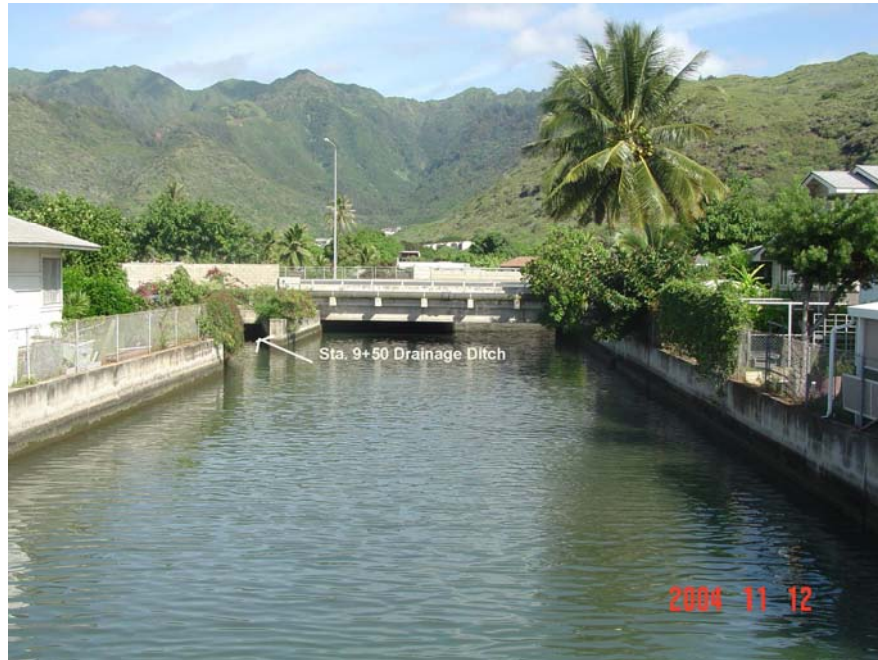
- u. Sta. 9+50, RB / LB, Cut back vegetation from sidewalls.

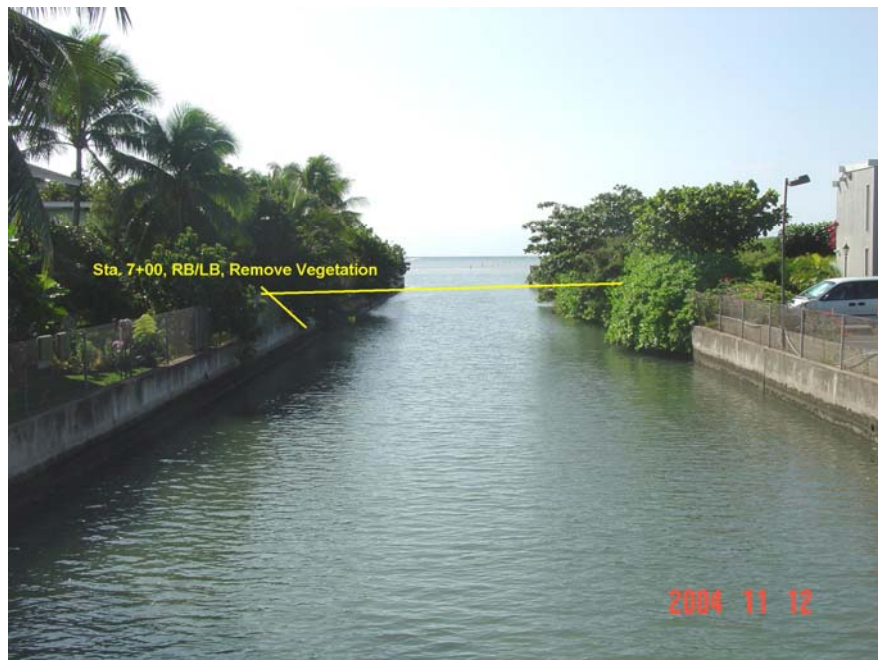
- v. Sta. 7+00, RB, cut vegetation from channel wall.

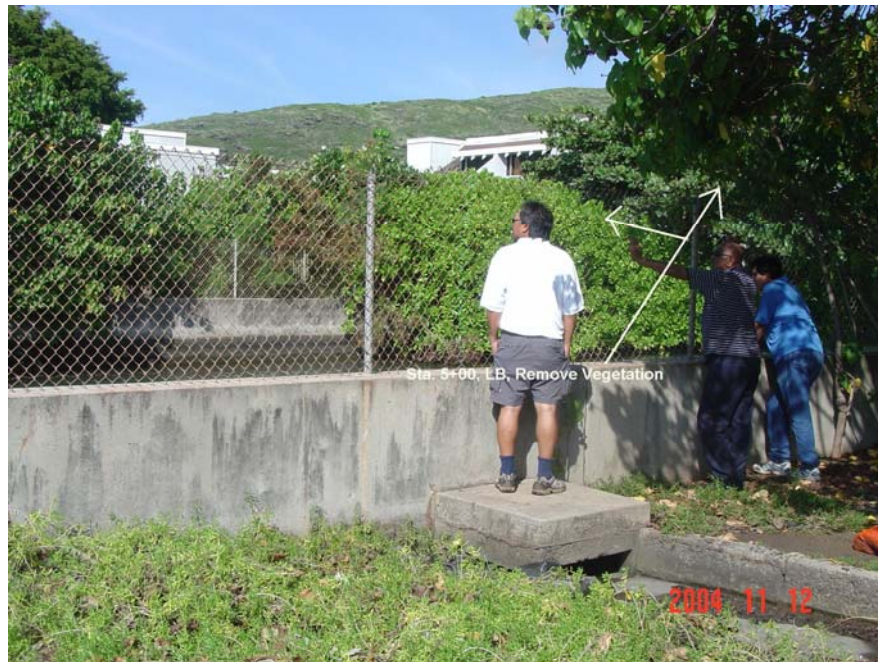
w. Sta. 5+00, LB, flapgate frozen open, repair or replace.
